Situation report – Red Ludwigia, Springfield (NSW Central Coast)

Sitrep No. - 1

Date of issue – 6 February 2018

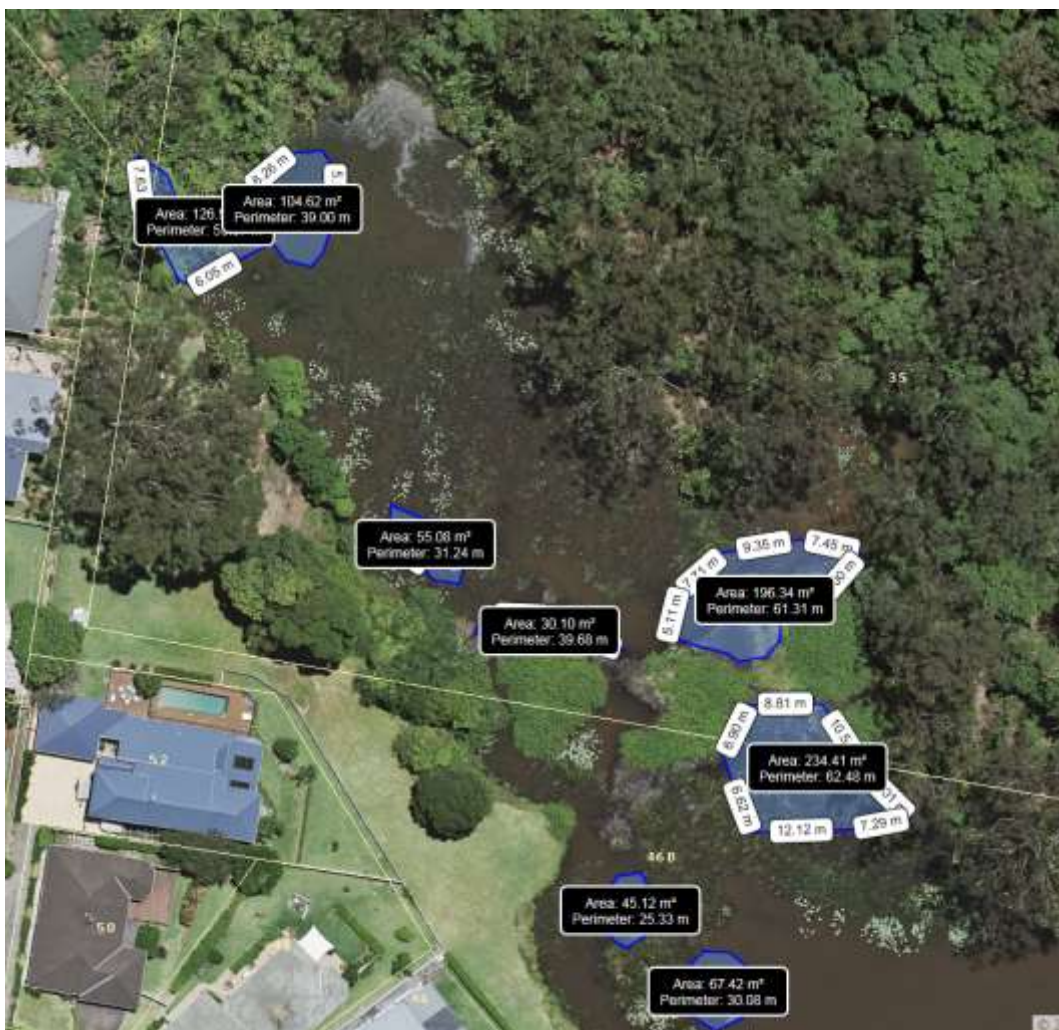
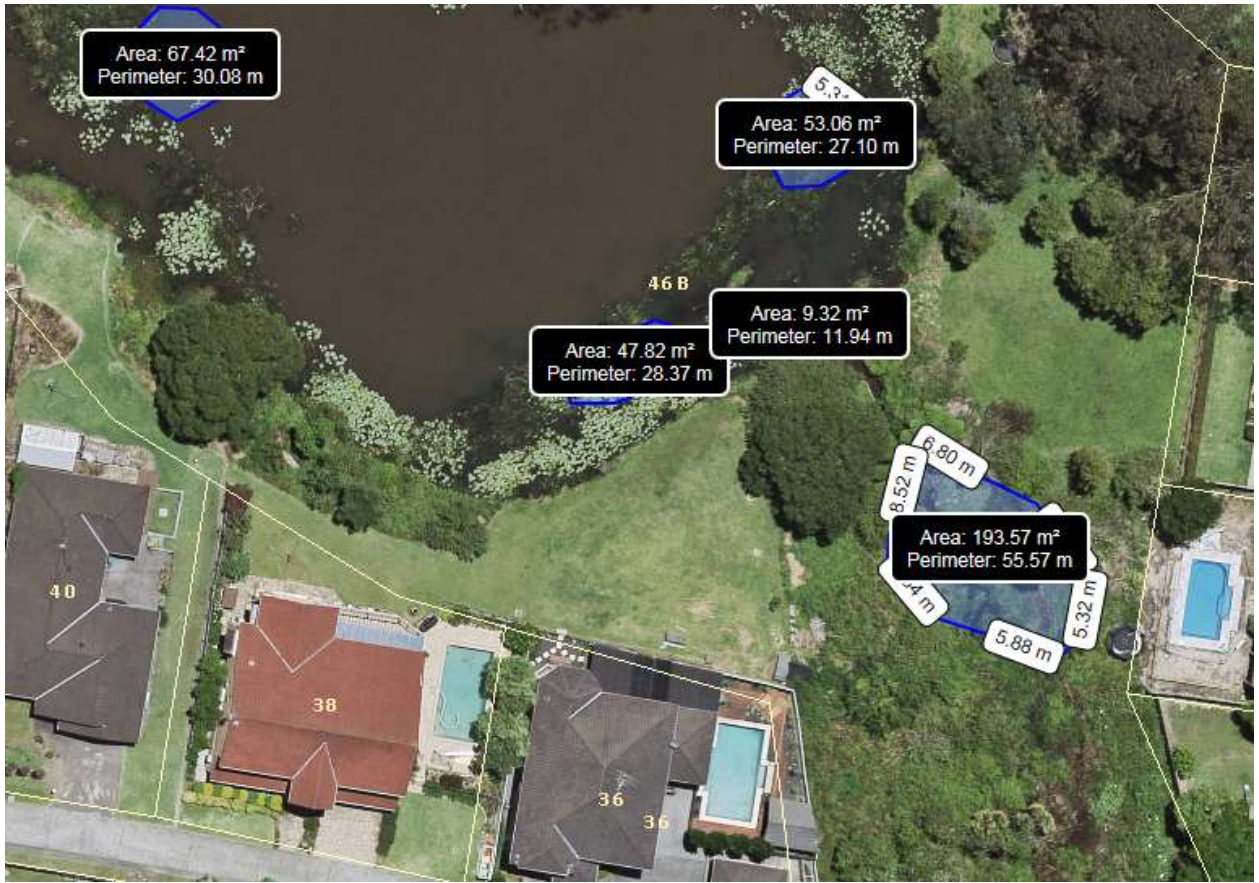
Map 1 Current locations of the emerged parts of the plant as of February 2019

Marked patches show current known locations and areas.
